12.01.11 Case Study : Curb Repair

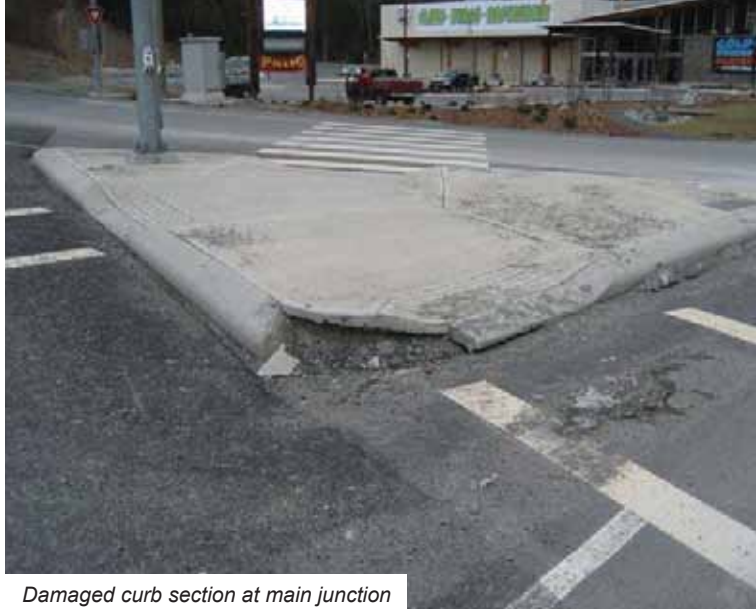
Damaged curb section at main junction

In January 2011, Miller Capilano Highway Services were commissioned via our Canadian distributor, Nuna Innovations, to trial the use of Concrete Cloth (CC) to repair damaged curbs. The void in the curb was first filled and then lined with CC8. The CC was wrapped around the curb and fixed into position using standard concrete anchor screws before hydrating. Following the success of the trial, which was completed in under two hours, a number of other curb sites are being considered for refurbishment using CC.

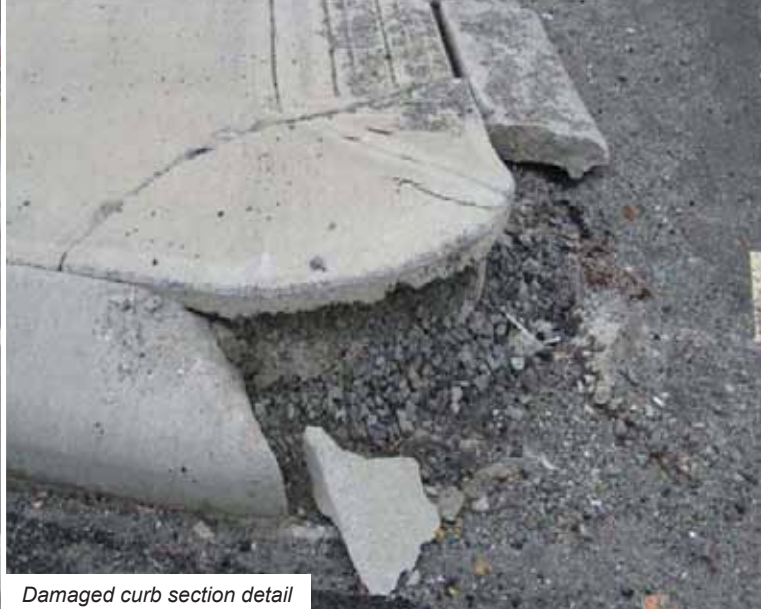
Damaged curb section detail

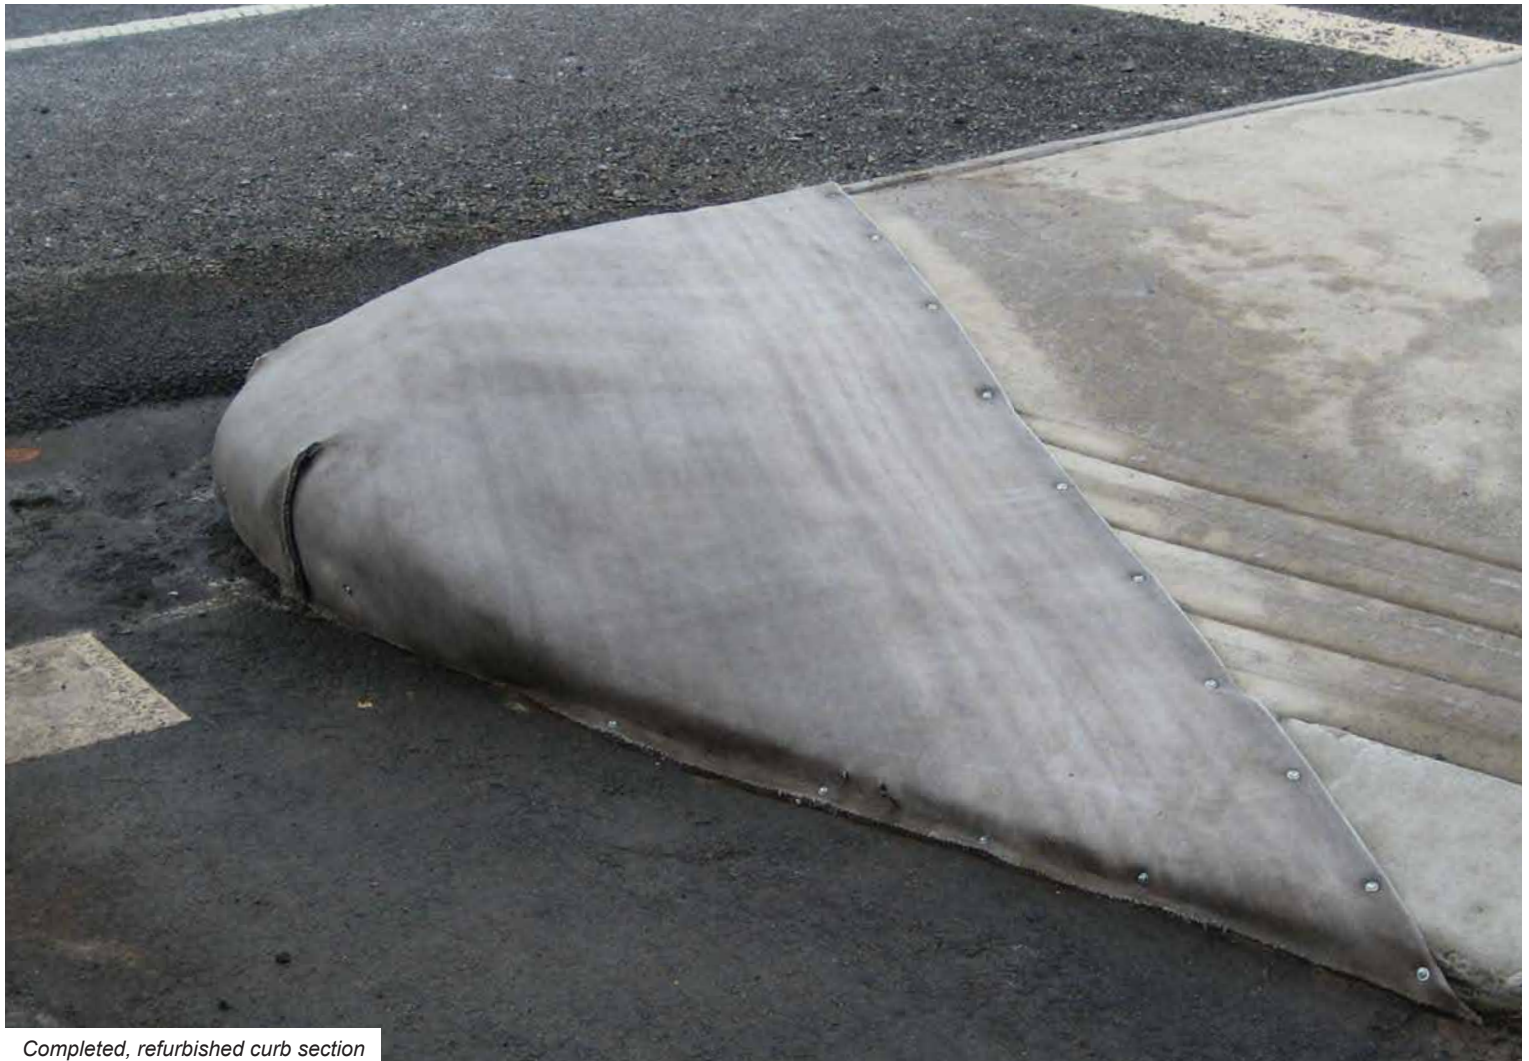
Completed, refurbished curb section
